# BIORETENTION BASINS

## STORMWATER MANAGEMENT PRACTICES GUIDANCE FOR PRIVATE OWNERS

LAND & WATER  
RESOURCES  
DEPARTMENT

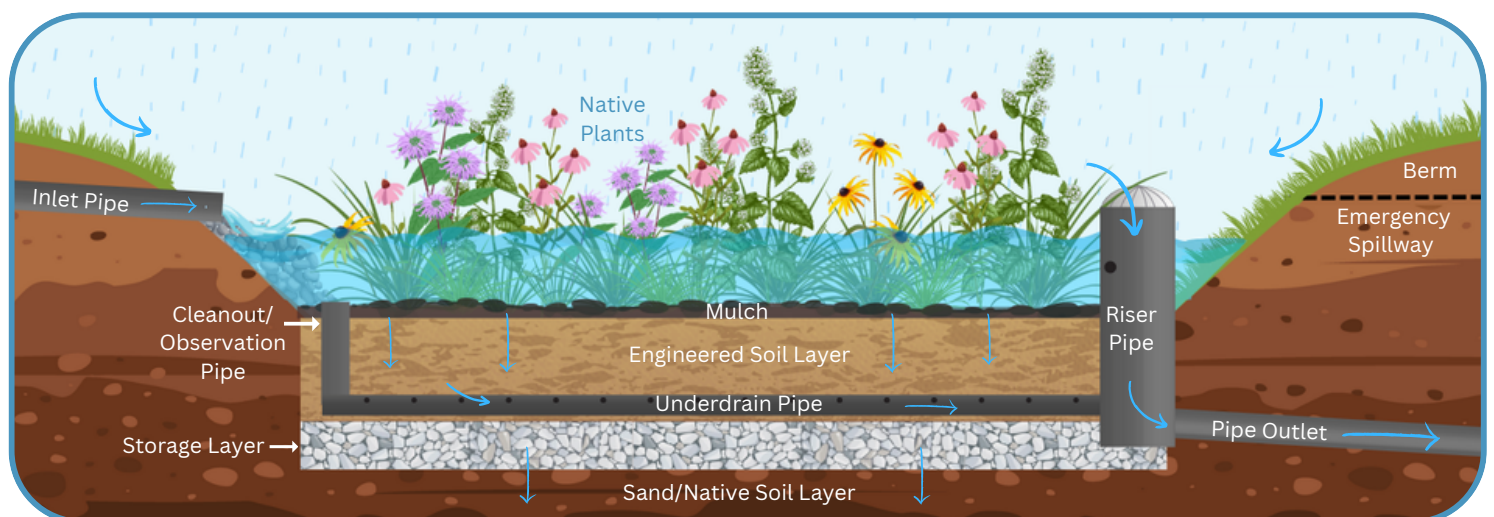
**Ponding Zone:** receives and holds runoff until it has an opportunity to infiltrate through the basin.

**Vegetation and Mulch Layer:** the first layer to be infiltrated by the runoff. Contains native plants and 2-3" of hardwood mulch or coconut mat to help suppress weed growth.

**Engineered Soil Layer:** composed of sand and compost, it facilitates plant growth and filters out pollutants.

**Storage Layer:** promotes infiltration. Since infiltration is the only way water is able to exit the storage layer, it is an important component of the bioretention facility.

**Underdrain Pipe:** a perforated pipe that is placed at the top of the storage layer as an outlet for runoff that cannot be infiltrated as quickly as needed. The underdrain must have a clean-out port that can be accessed for maintenance.

**Sand/Native Soil Layer:** an interface below the storage layer which is necessary when the native soil is not suitable for infiltration, such as clay soils.

### COMPONENTS OF BIORETENTION BASINS

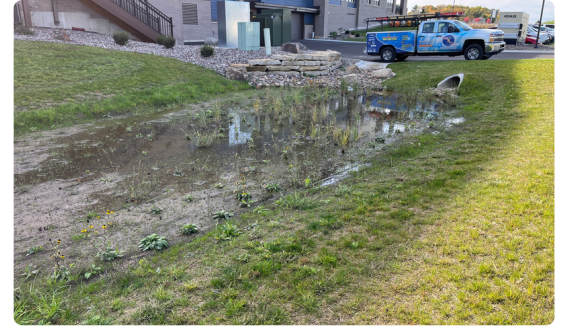
A bioretention basin that has remained wet due to clogging and overwatering, preventing proper vegetation growth.

| Problem | Possible Cause | Possible Solutions |
|---|---|---|
| Standing water within the infiltration area for more than 72 hours | The surface of the ponding area may become clogged with fine sediment over time. This might be because the pretreatment is no longer working, or there are excessive sediment loads due to erosion or high sediment loads from the contributing area. | <ul style="list-style-type: none"> <li>• Clean the pretreatment area more frequently</li> <li>• Scrape, clean or vacuum the infiltration area. A vacuum truck may be needed for sediment removal in the pretreatment area or BMP bottom</li> <li>• Core aeration or cultivating of non-vegetated areas may be required to ensure adequate infiltration</li> <li>• Ensure upland areas are well vegetated</li> </ul> |

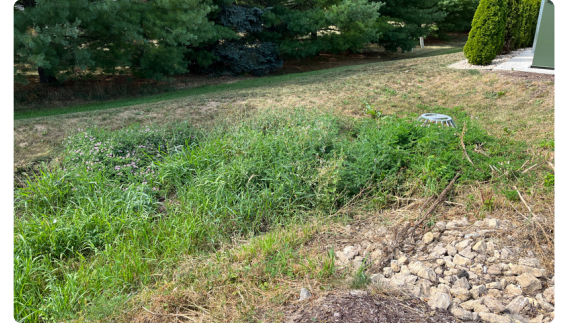
A bioretention basin that has not been properly maintained. Weeds have taken over and covered the outlet structure.

| Activity | Frequency | Maintenance Notes |
|---|---|---|
| Trash & Debris Removal | Every 1-3 months | Basin inlet and outlet structures should be kept clear of debris to allow stormwater to flow as intended. A blocked outlet pipe can reduce drainage capacity, resulting in overflow and erosion. This not only jeopardizes the basin's functionality but also poses a risk of potential structural damage. Basins near high traffic areas may collect more trash & debris. |

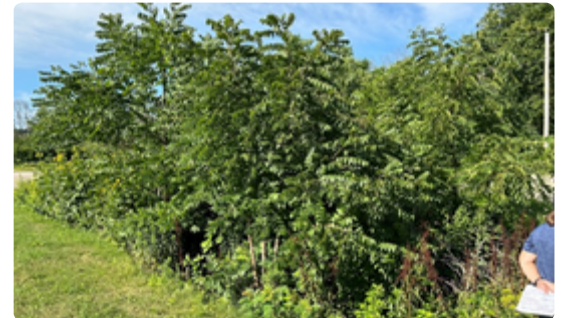
Before photo: vegetation management at a poorly maintained bioretention basin.

| Activity | Frequency | Maintenance Notes |
|---|---|---|
| Vegetation Management | As needed | <u>Maintain vegetation</u> type specified in approved plan. Remove all other vegetation from device as needed.<br><br>Vegetation plays a crucial role in the efficiency of a bioretention device. Routine vegetation management includes removing weeds, pruning shrubs, replanting in bare spots, removal and replacement of dead vegetation, and cutting back perennial plants each year in late winter/early spring. Watering may be necessary during extreme drought. |

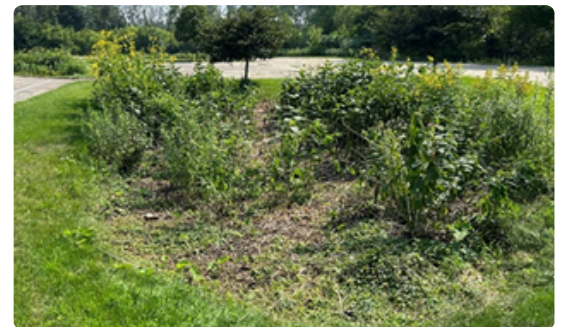
After photo: once woody vegetation and invasives were identified and removed, the basin needed to be replanted with native plant plugs to fill in bare areas.
